# PROPERTY REPORT

# 2018 MAIN STREET

Niagara Falls, New York

### **BUILDING SURVEY**

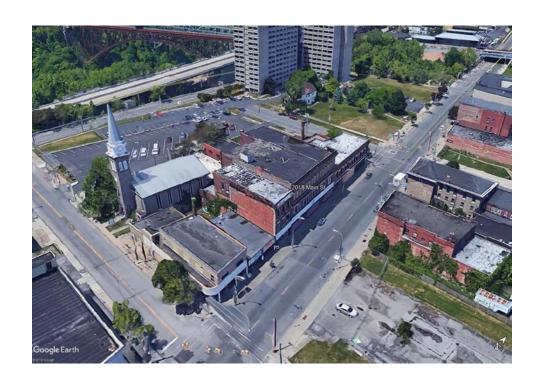
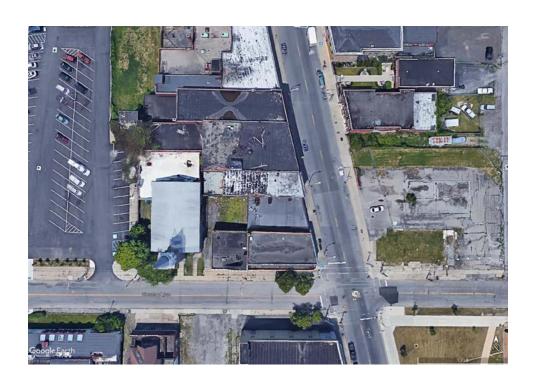
No access due to fire damage, building is a 3-story brick structure. Google Earth imagery shows extensive fire damage to the third floor and roof on the west end of the structure. It is assumed that fire and water damage have compromised the structural integrity of the building and that a complete demolition is necessary.
